HP 2600 Chip Technical Update

10.100x Errors
Attention Remanufacturers:

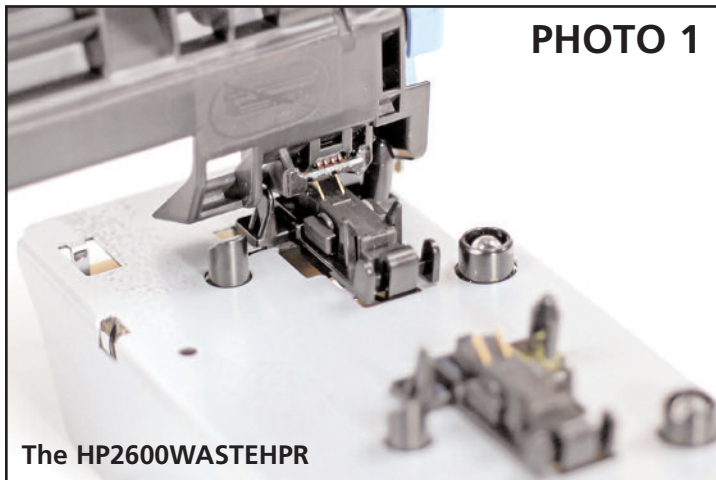
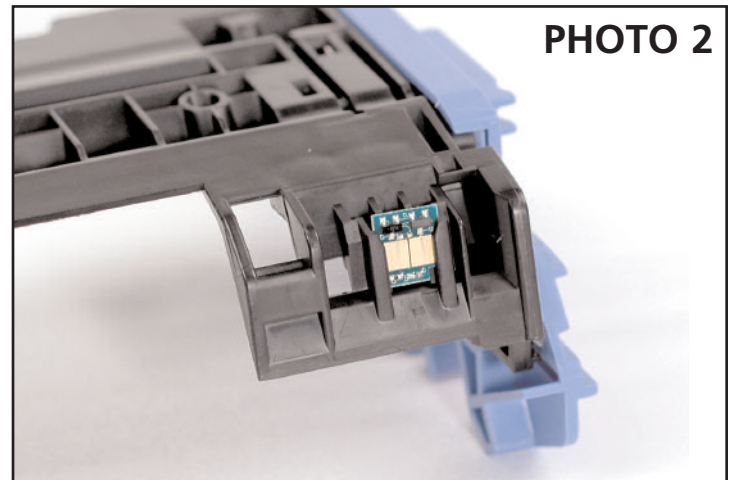
The use of any aftermarket HP2600 compatible replacement chip has the potential to cause a 10.100X error. This is because, as the printer ages, the contacts tend to lose their springiness. The following suggestions should eliminate any problems.

1. The HP2600WASTEHPR will greatly reduce the amount of movement of the contact alignment pins. When using the HP2600WASTEHPR, the chip can be replaced easily every time without cutting the chip alignment rails. **See photo 1**
2. If an error occurs, rock the cartridge slightly to assure that the contacts are touching the chip correctly.
3. Verify correct placement of chip on the waste hopper. **See photo 2**
4. Do not post test a chipped cartridge after remanufacturing. Also, for example, if you are rebuilding the HP2600 cartridge and testing it in a HP2605 printer, the **PRODUCT WILL LOSE ITS UNIVERSALITY AND BE DEDICATED TO THAT ENGINE.**
